**K-25****OAK RIDGE  
K-25 SITE****MARTIN MARIETTA**Comprehensive Environmental Response, Compensation, and  
Liability Act (CERCLA) Assessment

Oak Ridge Gaseous Diffusion Plant

April 1987

K/HS-168

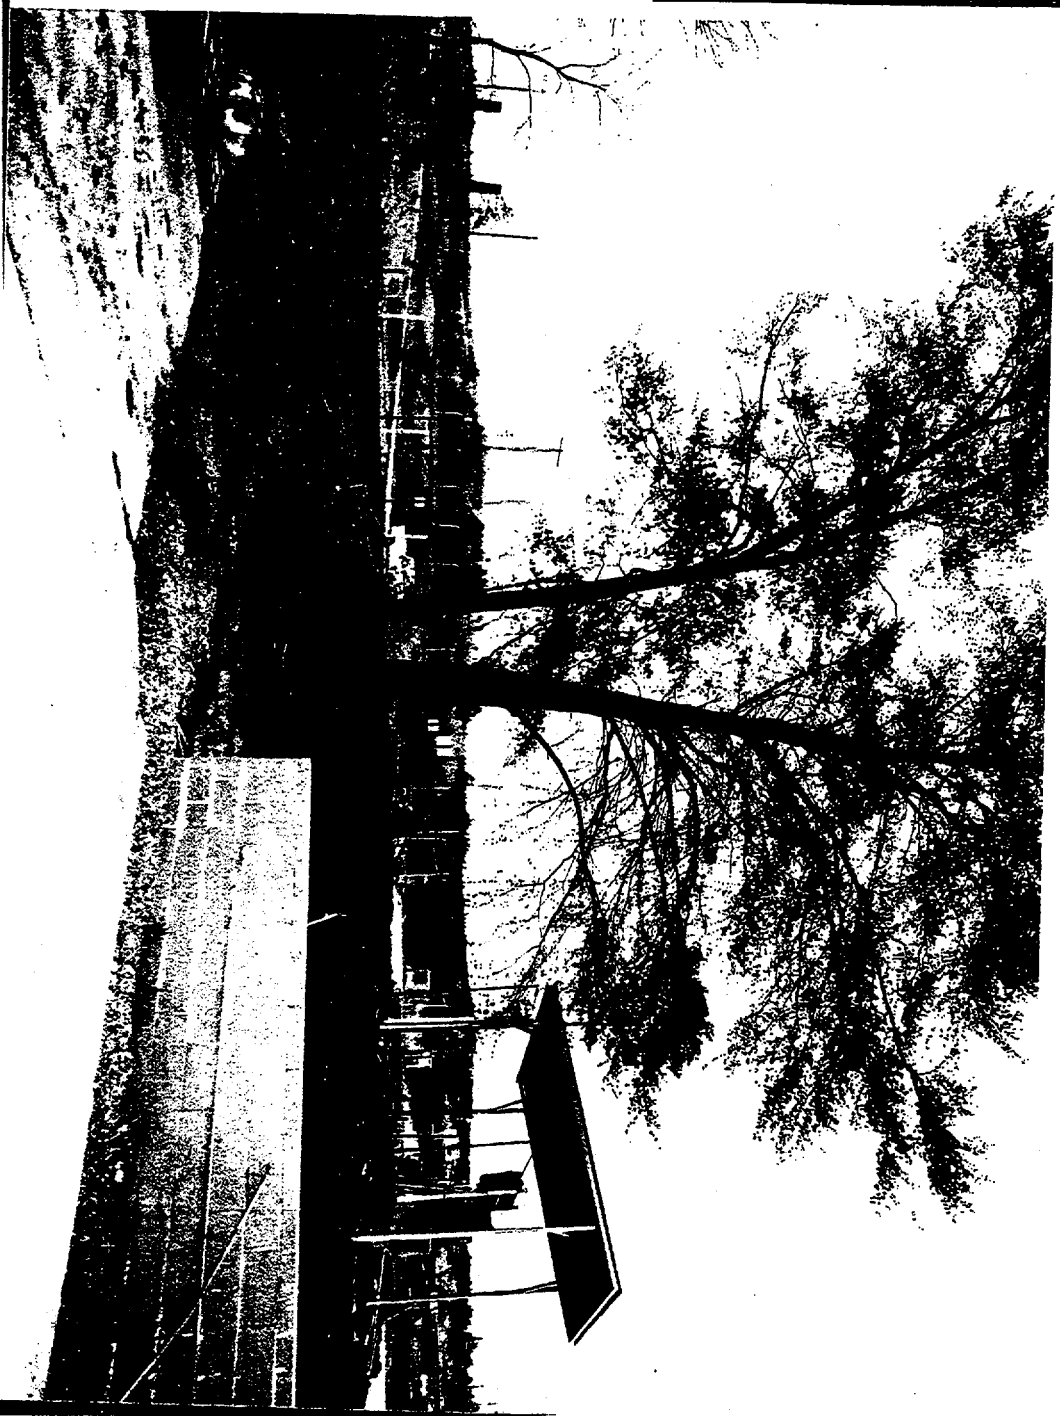
1. K-1414 Underground  
Fuel Tanks

CAPACITY Three underground fuel storage tanks with a total capacity of  
43,465 gallons.

In February 1987, the diesel tank leaked some fuel into the ground. The tank was removed and the leaked fuel was cleaned up. This is the only known release of material from this unit.

A RFI plan will be prepared for this unit and submitted to the Environmental Protection Agency by the end of CY 1988.

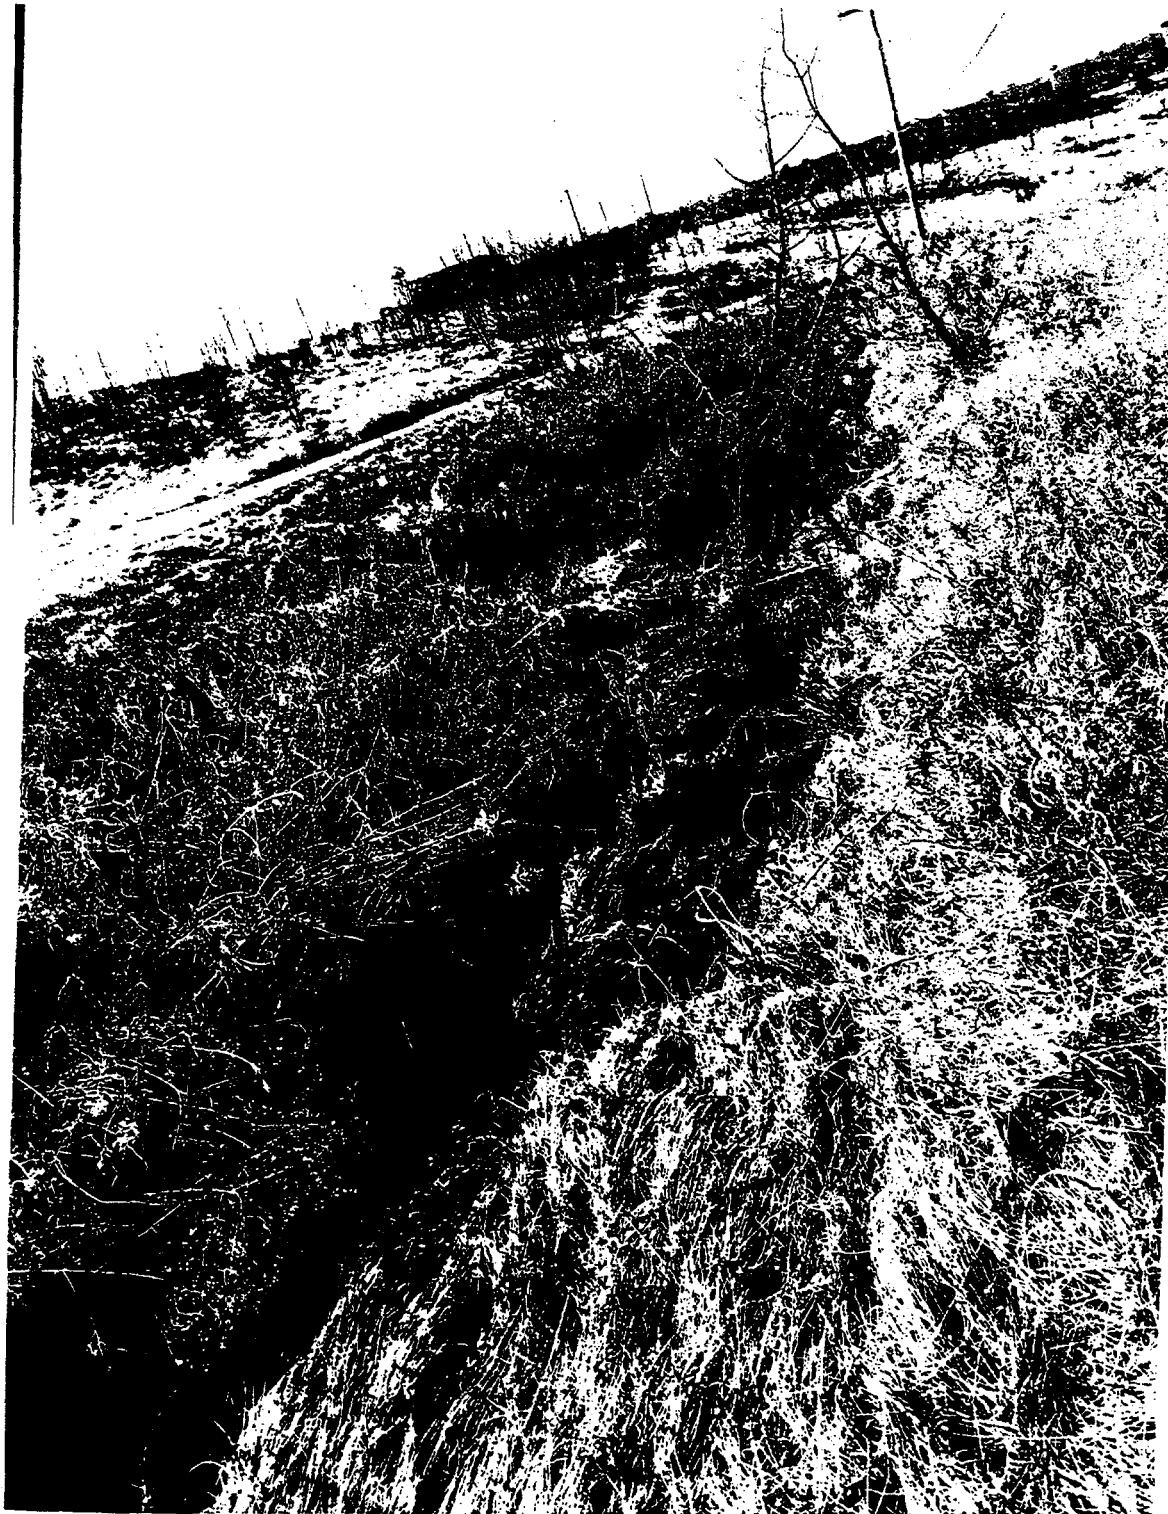
K-1700 Stream

This unit is a natural stream that receives treated wastewaters from various treatment facilities. Samples taken from the stream indicate that the sediments contain hazardous constituents that have settled into the sludge since the ORGDP has been in operation.

The stream has a NPDES permit at a point near its confluence with Poplar Creek. This permit has been in place since 1974. There have been occurrences when permitted parameters exceeded the discharge limits.

This stream is a transport mechanism for releasing hazardous and/or radioactive constituents into Poplar Creek since the stream collects wastewater from treatment units within the ORGDP facility.

A RFI plan will be prepared for this unit and submitted to DOE by the end of CY 1988.

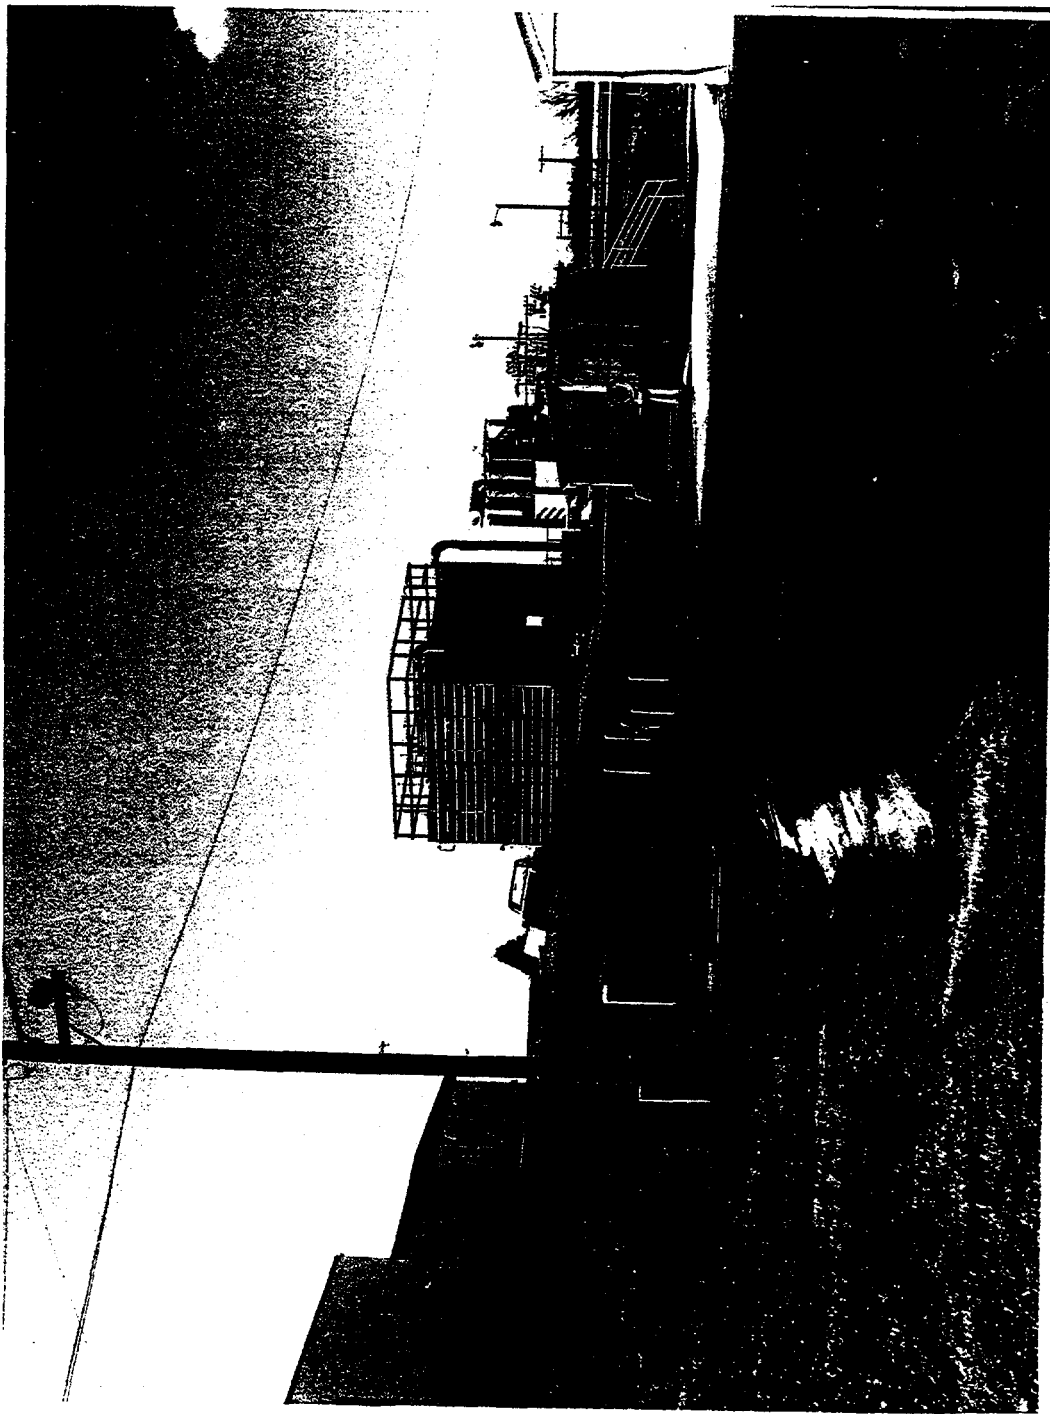
3A. K-1004-N Cooling Tower

A chromate, zinc, phosphate treatment was used for corrosion control. The chromate, while in the systems, was of the hexavalent form.

Various line breaks resulted in chromate releases. There is no available documentation of the locations.

Groundwater monitoring and soil sampling.

A RFI plan will be prepared by the end of CY 1988.
